JAFP-16-0134
August 23, 2016

Subject: LER: 2016-004, Transformer Fault Results in Manual Scram and
Secondary Containment Vacuum Below Technical Specification Limit

James A. FitzPatrick Nuclear Power Plant
Docket No. 50-333
License No. DPR-59

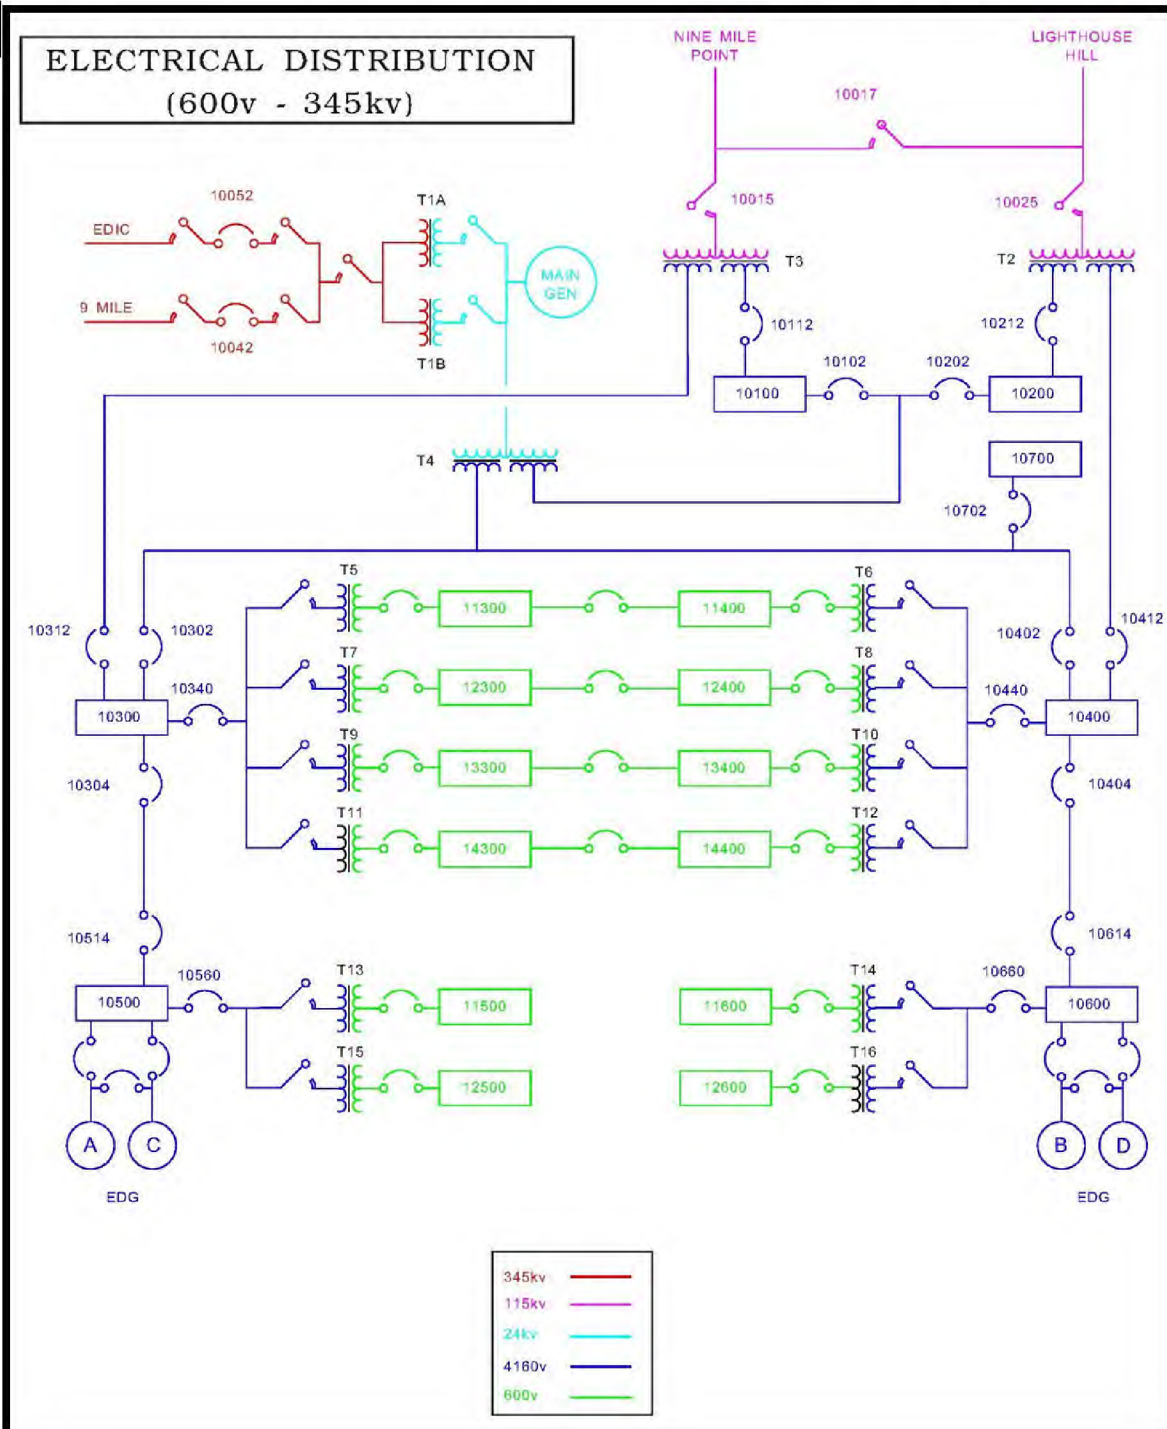
James A. FitzPatrick Nuclear Power Plant (JAF) 600V electrical distribution system [EIS identifier: EC] is supplied by stepping down 4160V to 600V through one of twelve transformers (T-5 to T-16). Nonsafety-related electrical busses are supplied by T-5 to T-12 and safety-related electrical buses by T-13 to T16. (See Figure: Electrical Distribution).

On June 24, 2016, at 12:05, when JAF was operating at 100% power, several 600V electrical busses lost power. A fault in 71T-5 caused breaker 10340 to trip. This breaker connects 4160V to four transformers which each provide power to a 600V bus: 11300 (L-13), 12300 (L-23), 13300 (L-33), and 14300 (L-43). These electric buses provide power to a variety of nonsafety-related plant loads; notable equipment include:
